BAD WHEEL STRAIGHTENING PRACTICES

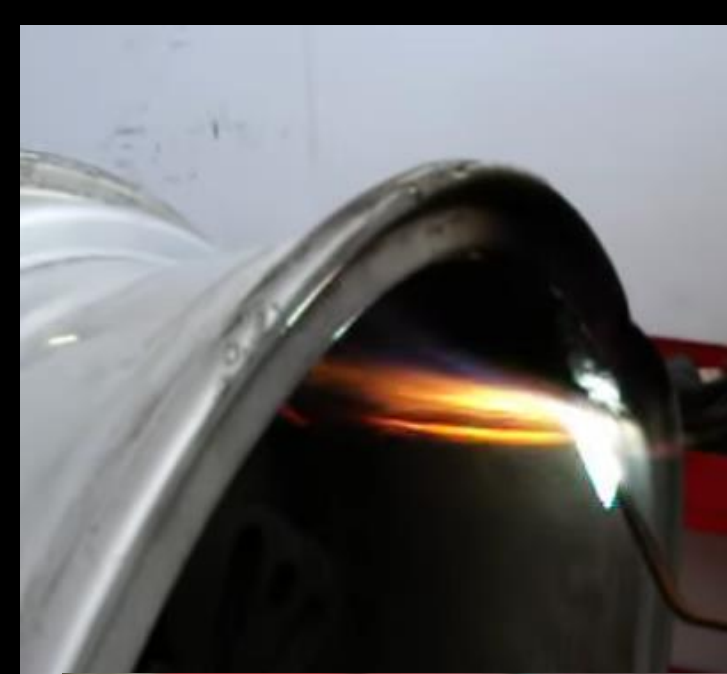
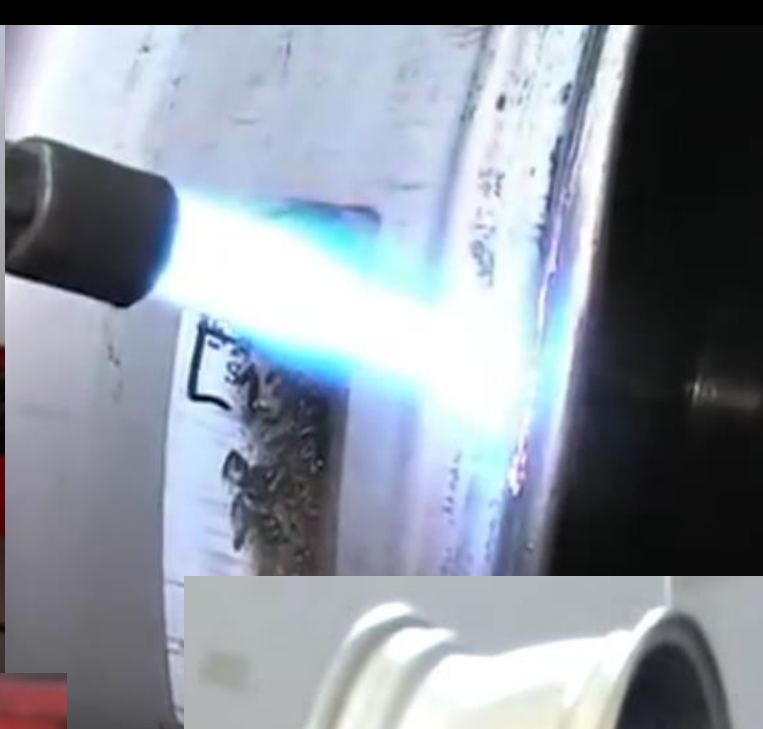
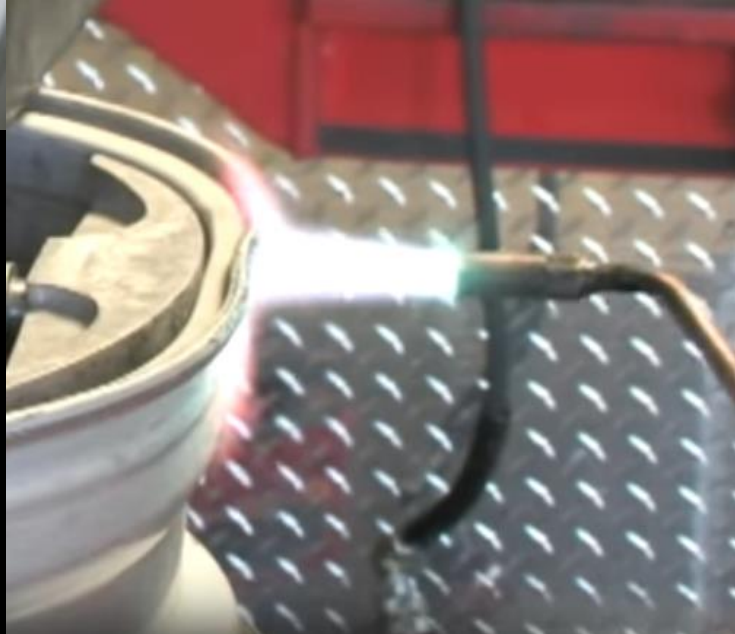
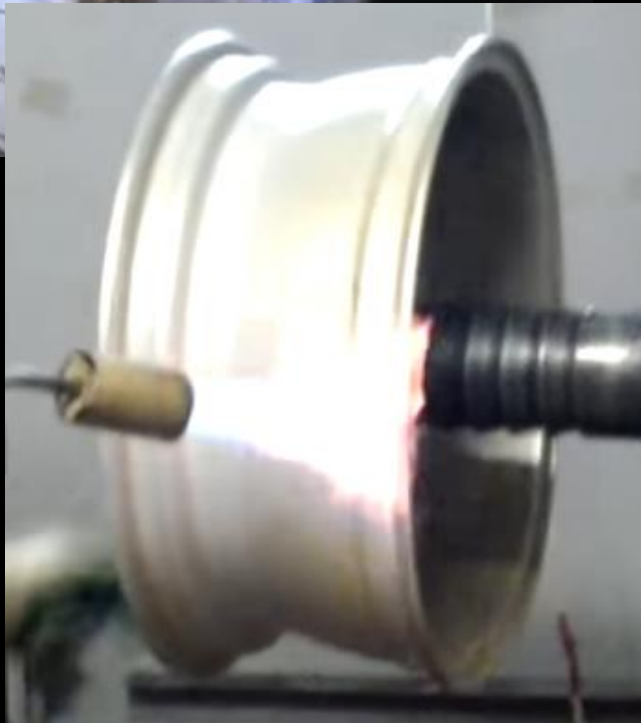
Excessive heating is the most common Bad Practice. When bending impact occurs, the molecular structure of a wheel becomes strained at the bend site. If that strain can be relieved properly, the wheel can be restored to a condition safe enough to pass all SAE performance tests required for brand new wheels. Heat makes the metal malleable. The more heat used, the easier the wheel is to straighten. However, if too much heat is used the heat-treat level (physical and chemical properties) are damaged and the wheel can easily bend, crack, or become deformed, all contributing causes of tire air loss. There is a fine line between safe and unsafe heating.

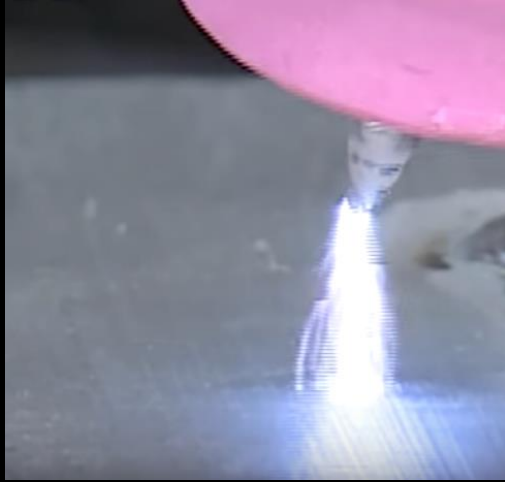
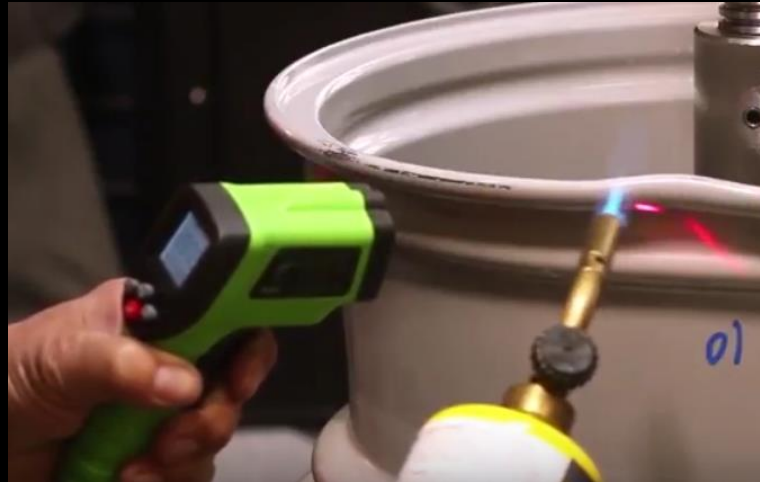
A TIG welding torch can be used to deliver a concentrated 3,000 degrees of heat to a very small area on a wheel. Keeping in mind that aluminum alloy melts at under 1,200 degrees, one can easily see that a TIG torch in the wrong hands could be disastrous. That's why monitoring wheel temperature with an Infrared Thermometer or Tempil stick is the only way to ensure that the wheel is not being damaged.

Oxy-Acetylene torches can also easily melt aluminum and there are numerous videos on the Internet which show these torches being used to heat wheels. Yet you will rarely see anyone monitoring the wheel temperature. Improper use of these torches can quickly heat a wheel to a unreliable level.

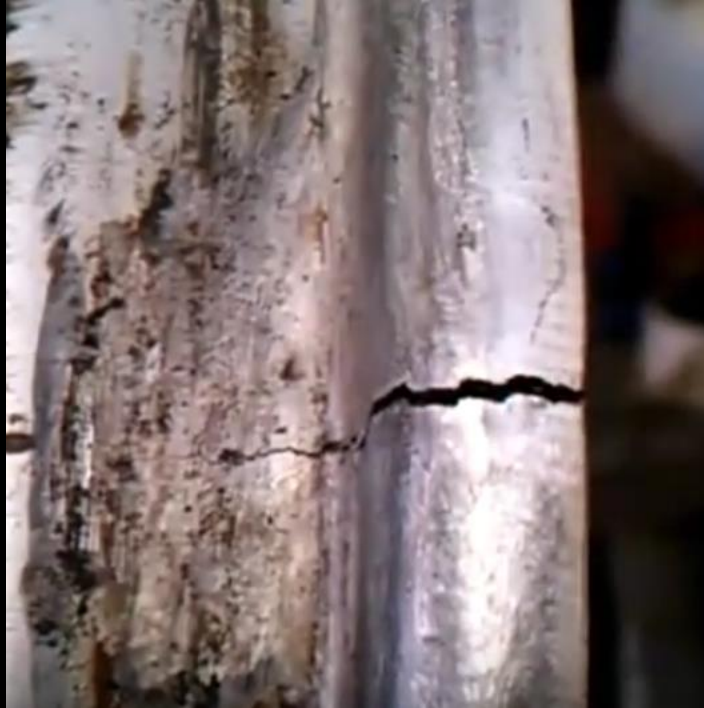
Depending on the methods used, a bent wheel can crack during straightening. If the structure of the wheel is damaged to the point of cracking, it is better that it cracks in the repair process than while driving.

A wheel that cracks during straightening should immediately be taken out of service. But all too often that is not the case.

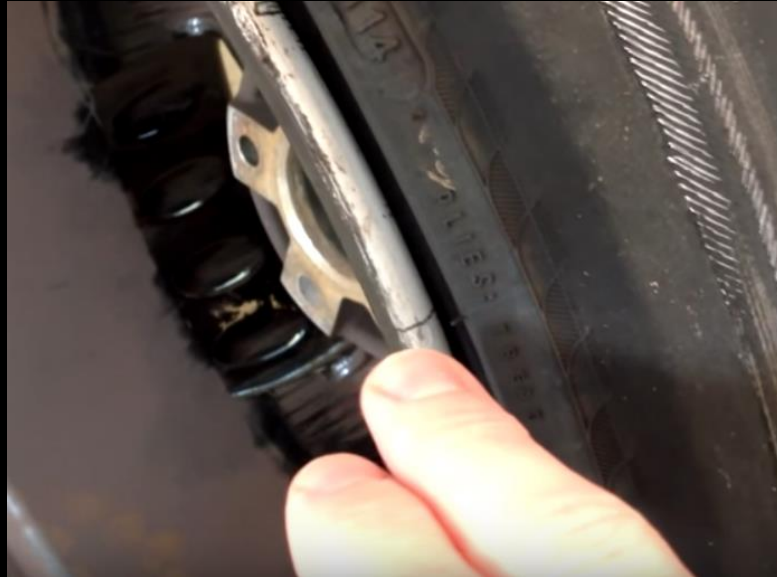
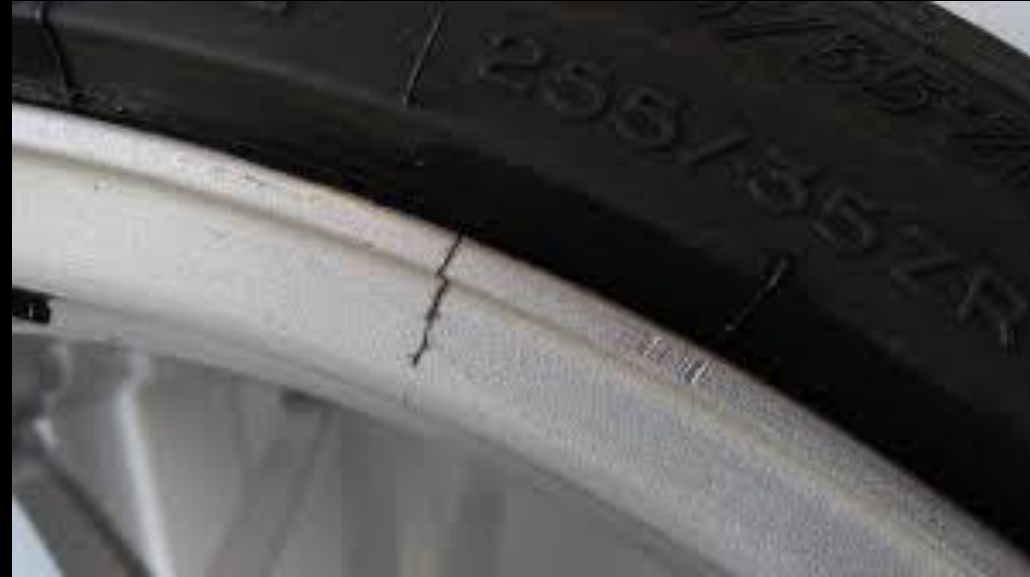
All cracks are serious but some present a bigger problem than others. Some are very small and do not extend into the bead seat. Cracks are halted by drilling a small hole at the base. The crack and surrounding area must then be properly prepared before welding. If this can be all be done by a qualified person without altering the heat-treat level of the wheel or disturbing the bead seat, the repair could be safe. But unfortunately that is usually not the case.

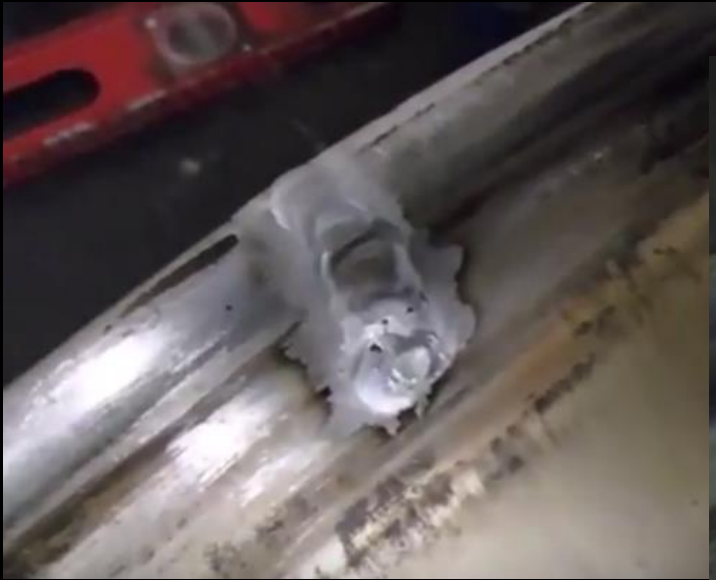
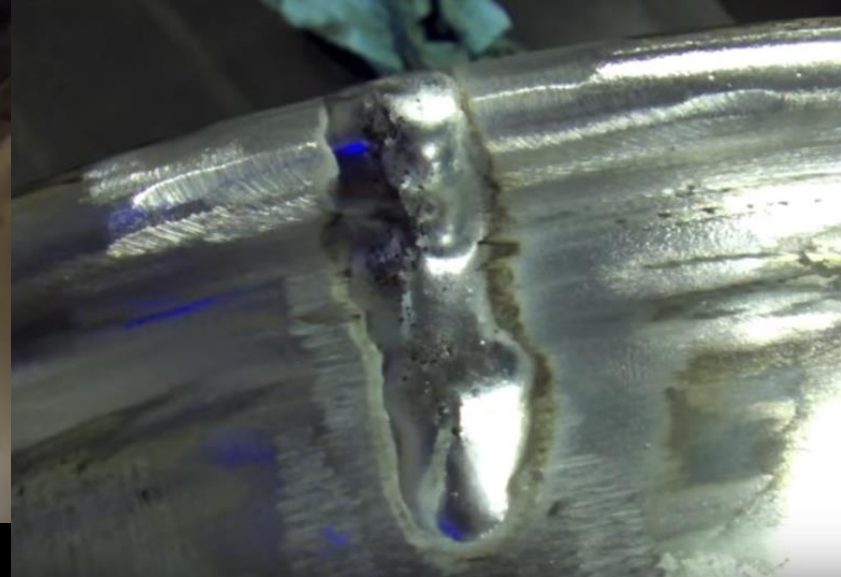
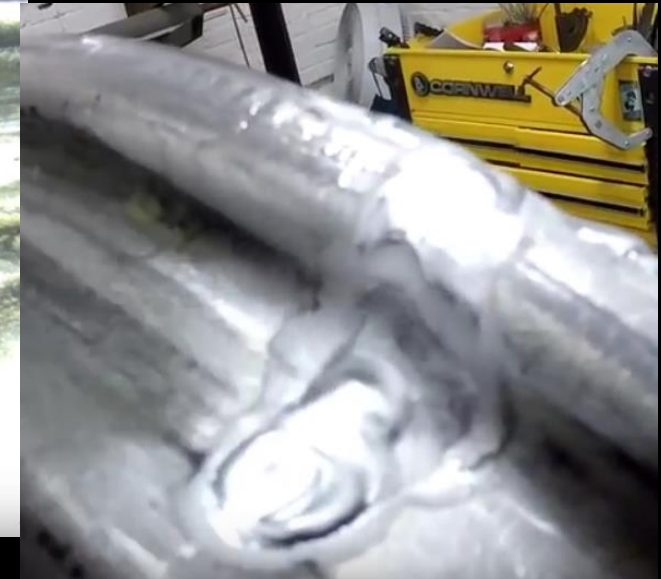
The bead seat of a wheel is a critical surface. The distance between the bead seat and the wheel center bore is vitally important. Precise dimensional and concentric tolerances must be maintained so there is no air loss. To prepare the surfaces for welding, the bead seat around the weld and the inside of the flange must be ground or sanded. These processes in and of themselves could alter the critical dimensions in those areas. And if the heat-treat level of the wheel is altered during welding, irreparable damage will have been done to the wheel and anything else is moot.

Shown here are examples of weld repairs across a bead seat. Even though the quality of these welds might be acceptable, the local dimension of the bead seat has been altered and needs to be smoothed down. The methods used to restore the critical dimension is where additional problems lie.

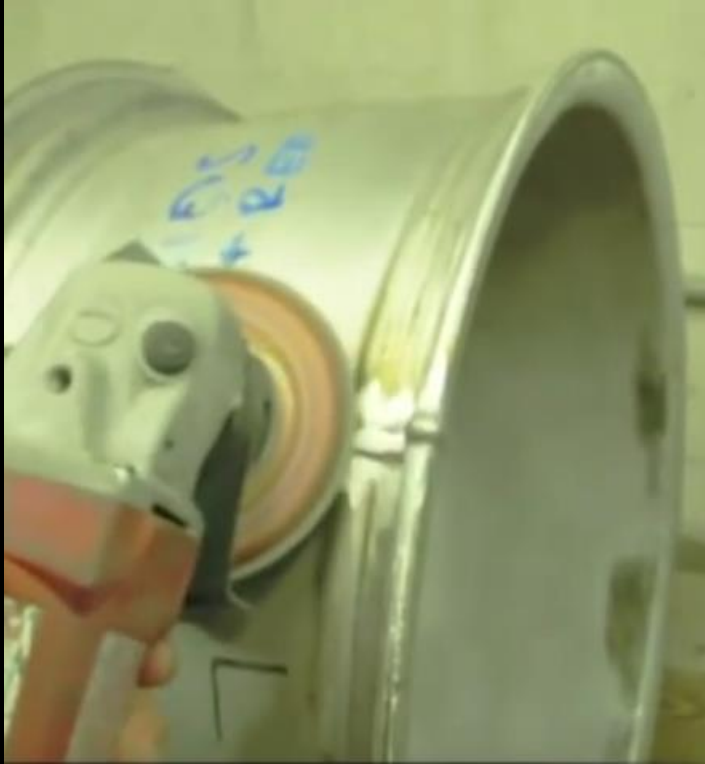
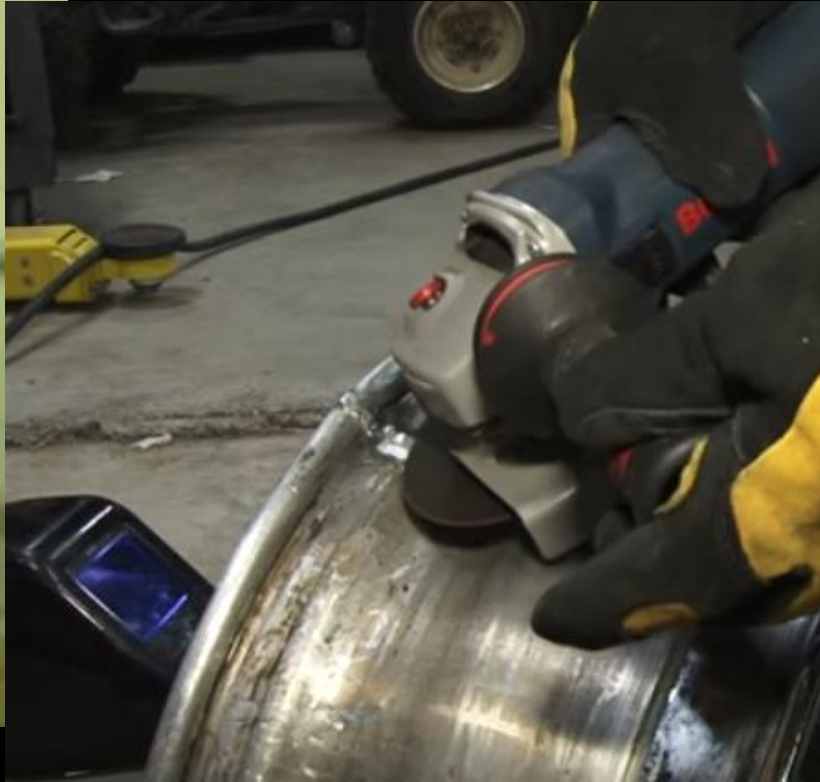
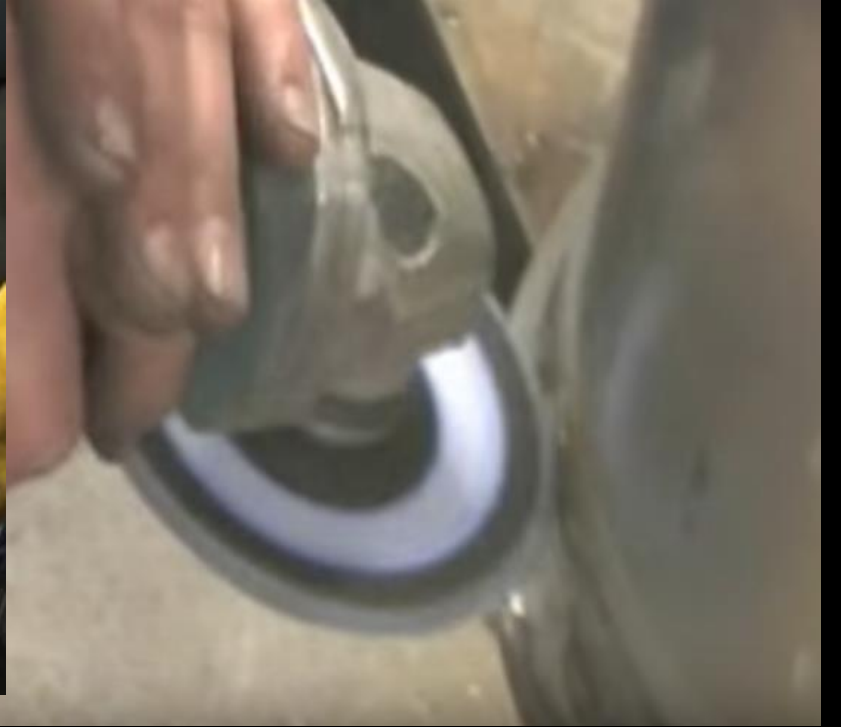
The process of smoothing and blending the weld in the bead seat is usually done by hand with grinding or sanding tools. These methods cannot insure that the surface in the bead seat is returned to the original finish and dimensional tolerances. These photos speak for themselves.

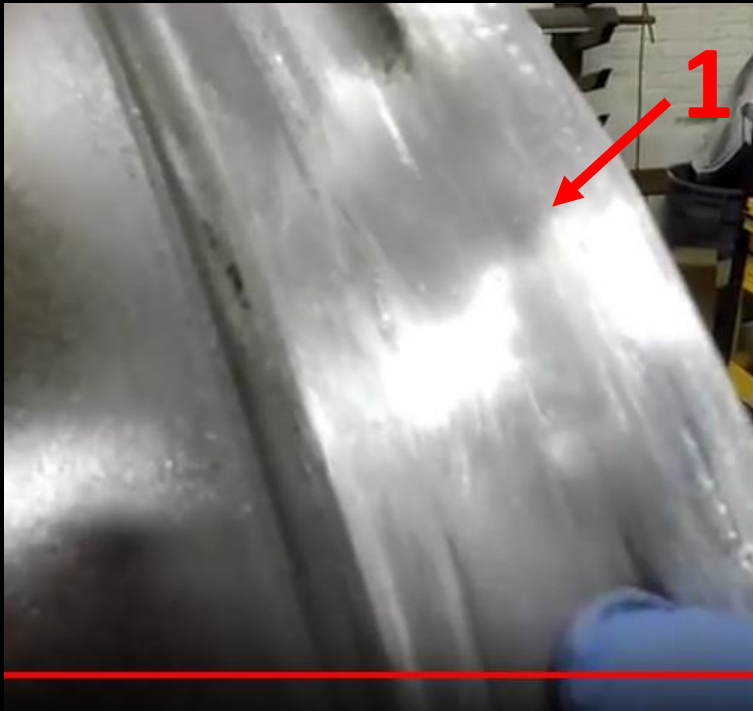
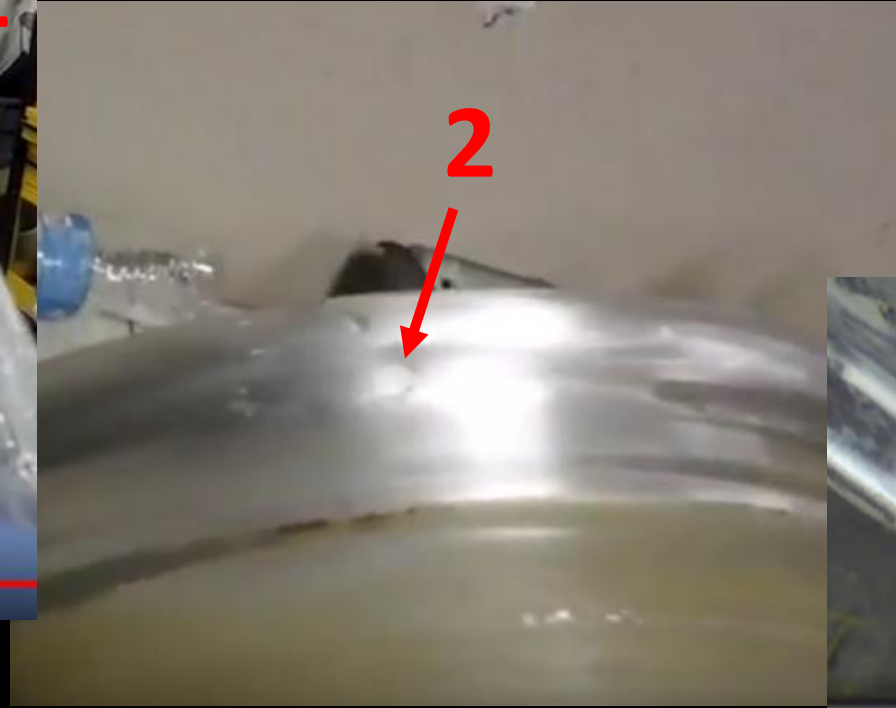
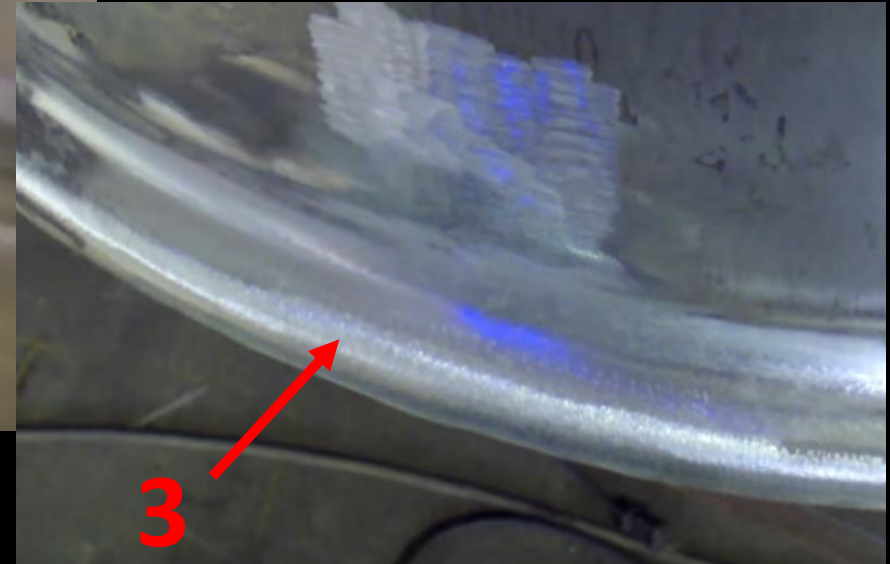
The finished product typical of repairs using methods shown in the previous slide look pretty good. But closer inspection reveals some flaws which could allow air leaks.

- 1- Low area at rear of flange
- 2- Depression at base of flange and bead seat
- 3- Uneven bead seat.

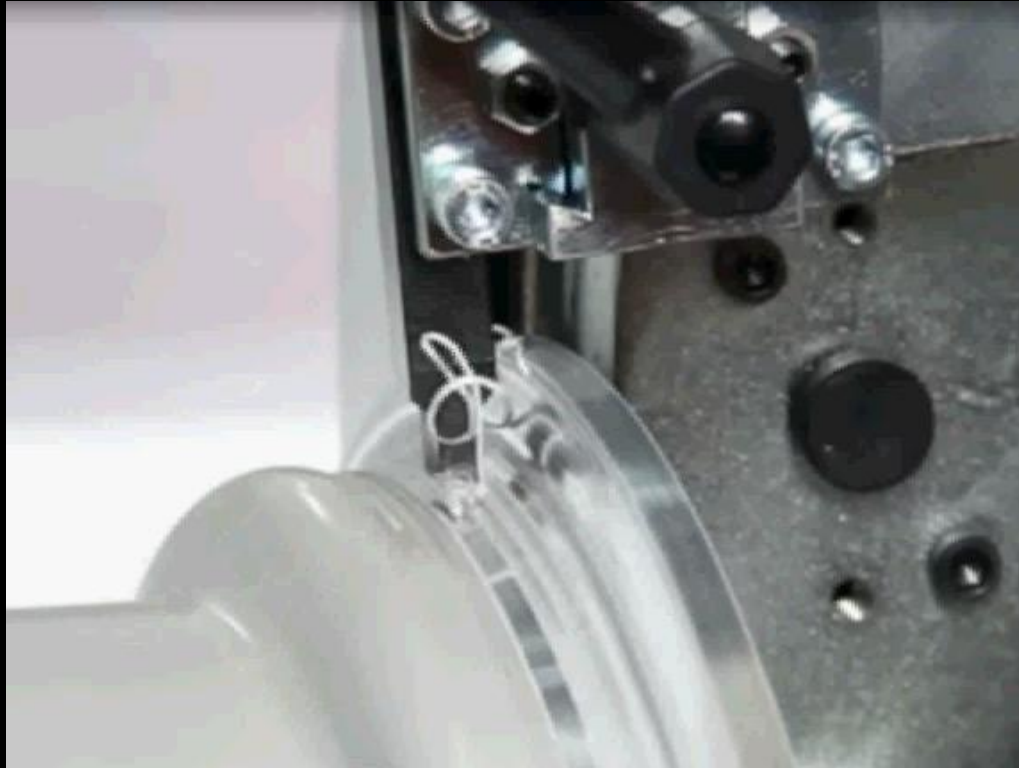
The most dangerous example of wheel repair is shown here. The bead seat is actually being machined on a lathe. Precision turning will result in a smoother and better blended finish than the hand grinding method, but the critical relationship between the wheel center bore and the entire bead seat has been compromised. This YouTube video shows an example of what could happen if the bead seat is machined. And during hard cornering, that tire could actually come off the rim. Watch video here: <https://www.youtube.com/watch?v=maLLjFgYWak>

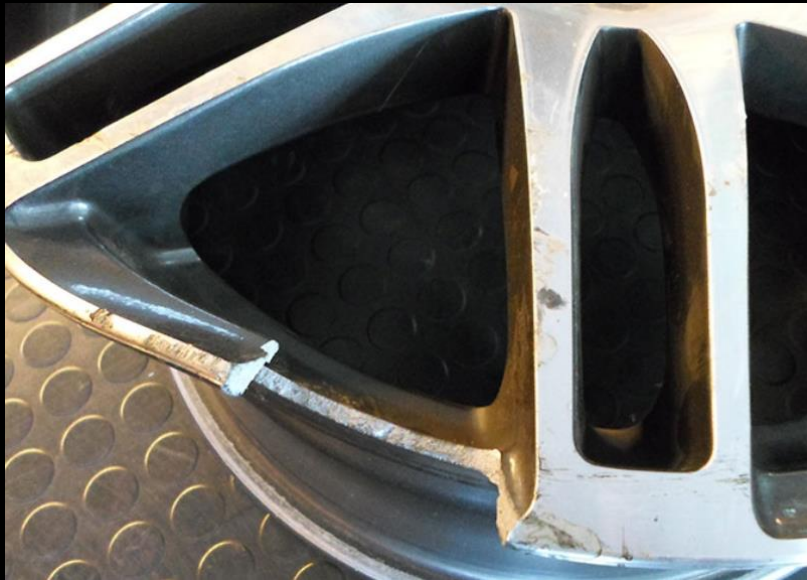
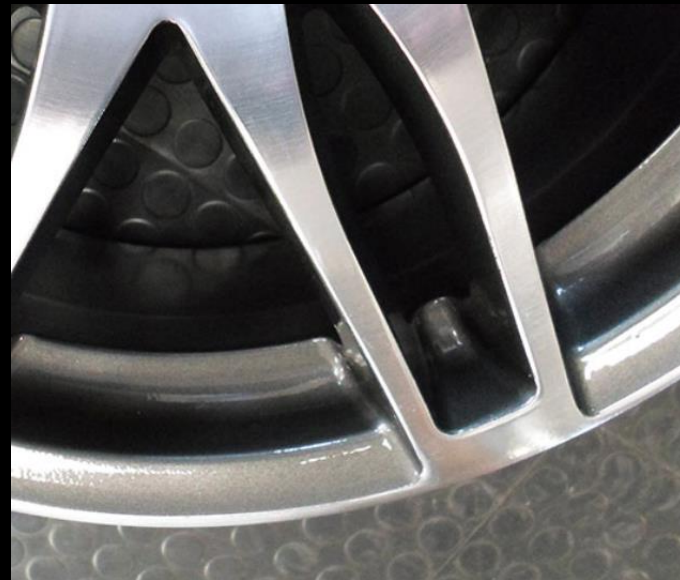
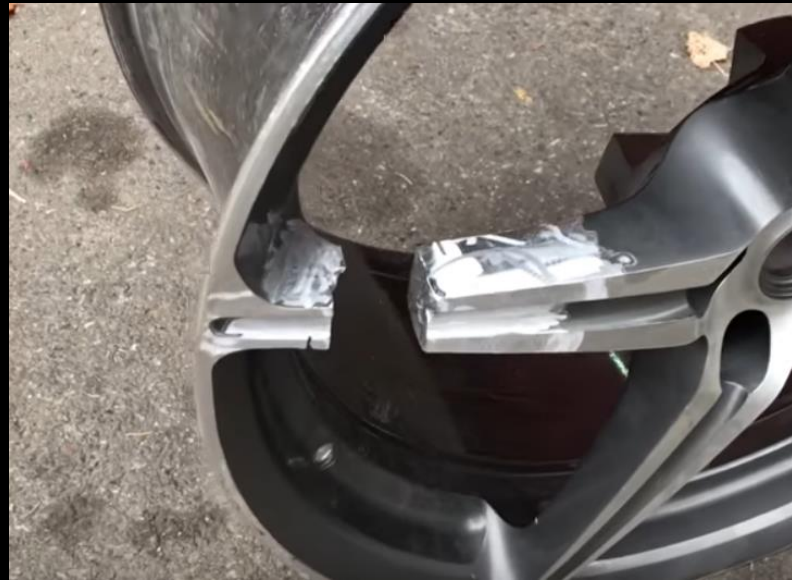
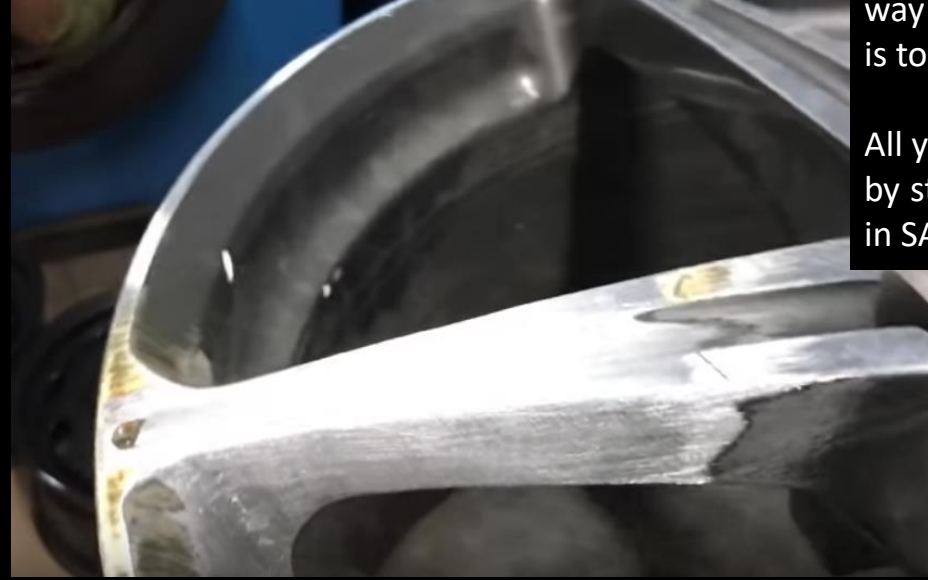
The wheel straightening repair market has become so competitive that examples of extreme practices can easily be found all over the Internet. Shown here are photos of unwise and irresponsible restorations.
