BAD WHEEL STRAIGHTENING PRACTICES

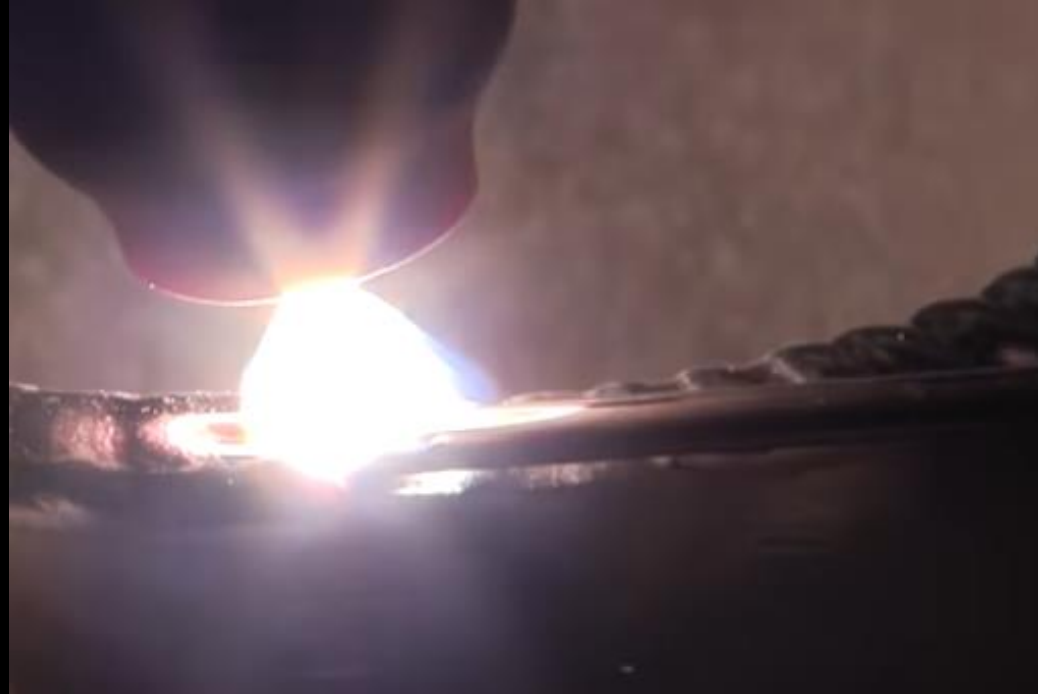
Proper welding methods are critical in the wheel repair process. TIG welding is not difficult to learn and is often one of the main problems in wheel straightening repairs.

Cosmetic TIG welding enhances the beauty of the wheel. It never affects the wheel bead seat and is not a structural repair. If done properly, it will not affect the physical and chemical properties of the metal. Cosmetic TIG welding can be done safely but it is only possible if the welder is experienced enough to understand the metallurgy of an alloy wheel and just how precisely filler material must be added.
